**FEDERAL AVIATION ADMINISTRATION  
AIRWORTHINESS DIRECTIVES  
LARGE AIRCRAFT**

**BIWEEKLY 2000-08**

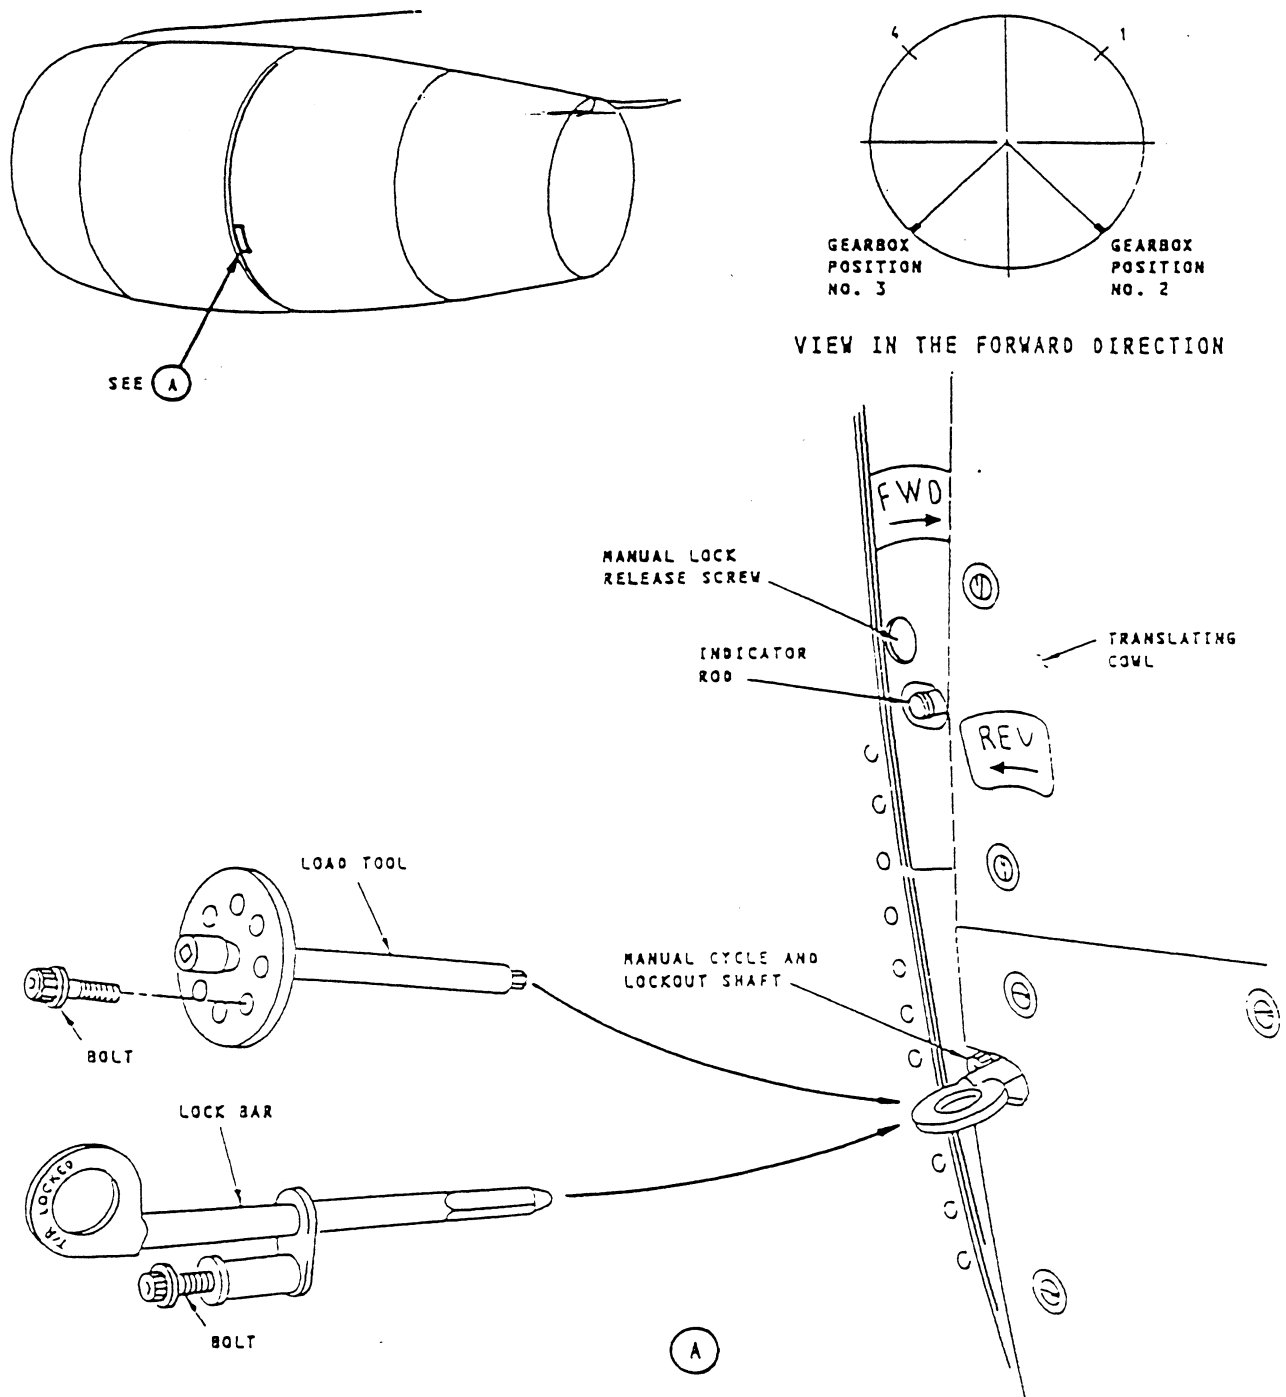
Lock Bar/Load Tool Installation and Gearbox Manual Lock Release  
Figure 1

- 4) Apply a torque counterclockwise through the manual wind position of the No. 3 gearbox.
  - a) If the translating cowl does not move, the lock bar touched one of the two lock dogs.
  - b) If the translating cowl moved, lock the thrust reverser until the No. 3 gearbox is replaced.
- 5) Turn the manual lock release screw counterclockwise to release the gearbox lock.
  - a) Make sure that the indication rod comes out of the No. 3 gearbox.
- 6) Turn the manual cycle and lockout shaft counterclockwise 1/4 turn.
- 7) Turn the manual lock release screw clockwise to engage the No. 3 gearbox lock.
  - a) Make sure that the indication rod is fully retracted (under the surface).

- 8) Apply a torque counterclockwise through the manual wind position of the No. 3 gearbox.
  - a) If the manual cycle and lockout shaft can not be turned more than approximately 1/4 turn, the second lock dog is serviceable.
  - b) If the manual cycle and lockout shaft can be turned more than approximately 1/4 turn, the second lock dog is unserviceable. Lock the thrust reverser until the No. 3 gearbox is replaced.

**NOTE:** The two lock dogs are found 1/2 turn apart when you use the manual cycle and lockout shaft. If necessary, do the check again to make sure that the lock dogs are serviceable.
